## STONE FOUNDATION AND BASEMENT HEALTH INSPECTION REPORT

**Private Residence**  
**Newburyport, Massachusetts**

Homebuilt: 1899 | Public sample report

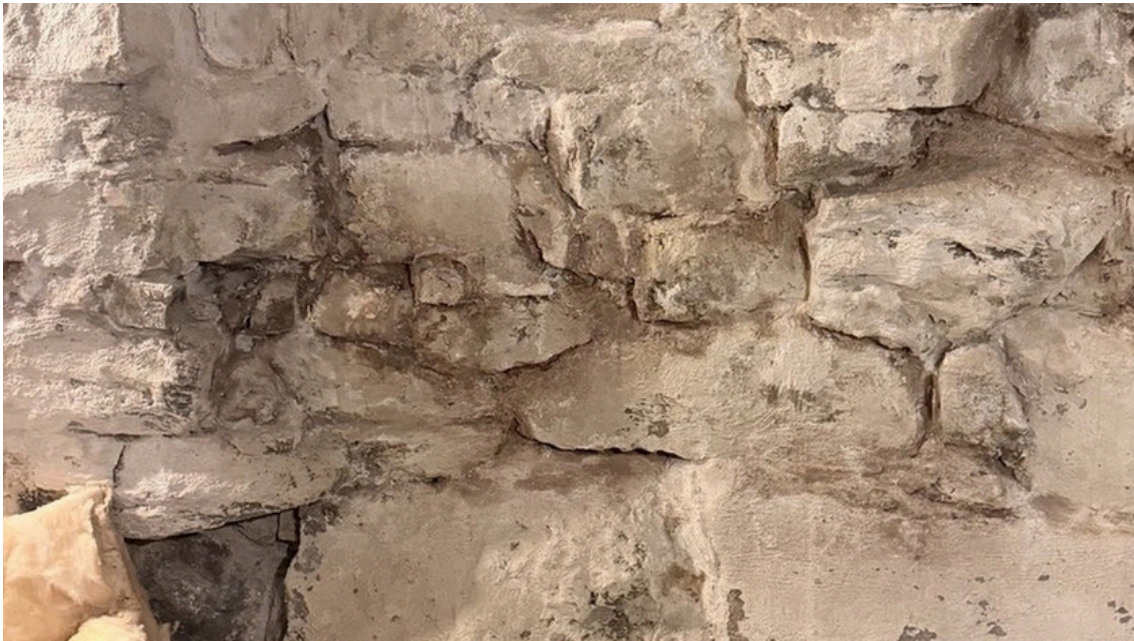
*Interior stone foundation conditions reviewed as part of the basement moisture assessment.*

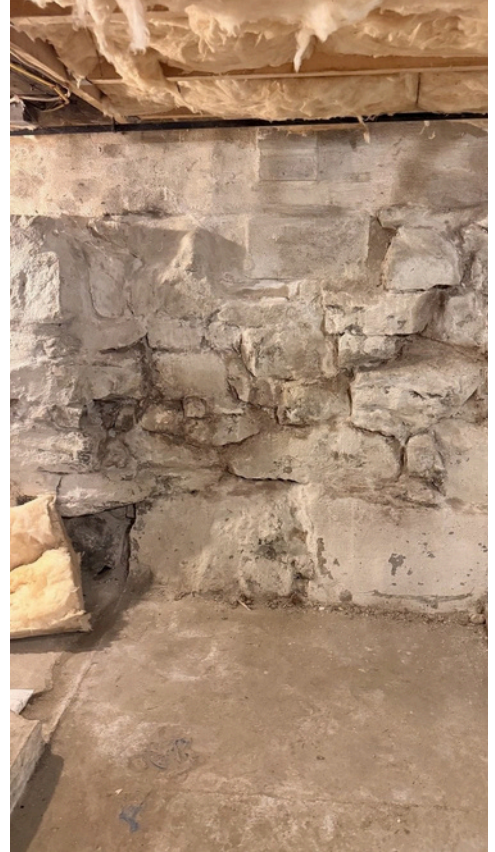
The original portion of the home is supported by a stone foundation. Previous repairs were identified as having been completed with Type S mortar, and portions of the stone foundation have been coated with DRYLOK masonry waterproofing coating.

Historic stone foundations from this period were commonly built with softer, more vapor-permeable lime-rich mortar. A hard cement-based repair mortar can behave differently from the original masonry and may redirect moisture into adjacent stone or older mortar. DRYLOK on the interior can further restrict inward drying. When exterior moisture continues to reach the wall, moisture can remain within or behind the masonry system rather than drying as freely toward the basement.

Visible patching, staining and moisture-related deterioration indicate that the wall has been exposed to moisture over time. Additional coating alone would not address the underlying water source.

*Original stone foundation showing extensive previous patching and repair work.*

**Recommendation:** Evaluate deteriorated or incompatible repairs, remove loose/failing coatings where appropriate, repoint with a mortar compatible with the historic stone masonry, and use a breathable foundation treatment rather than simply adding more DRYLOK.

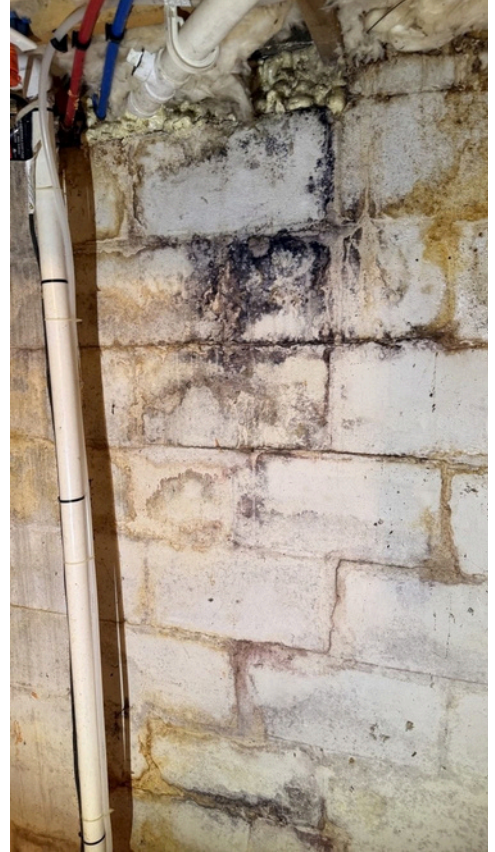
A later addition to the home is supported by concrete masonry unit (CMU) foundation walls. The exact date of this addition is unknown. The CMU walls have also been coated with DRYLOK. Visible moisture staining, discoloration and darkened areas are present on the block wall. Several areas contain visible staining and growth consistent with mold. No laboratory mold testing was performed, so the presence, type and extent of mold cannot be definitively confirmed.

Concrete block is porous and can transmit moisture through the block, mortar joints, openings and the wall-to-floor connection. Interior DRYLOK does not correct an exterior water source. Where moisture continues to enter the block, the coating can restrict inward drying and allow damp conditions to remain behind or within the wall system.

*CMU wall with DRYLOK, moisture staining and dark growth/staining consistent with prolonged damp conditions.*

**Recommendation:** Correct exterior water sources and repair active openings before relying on interior coatings. Any cleaning or remediation of suspected mold should be performed after the moisture source is controlled.

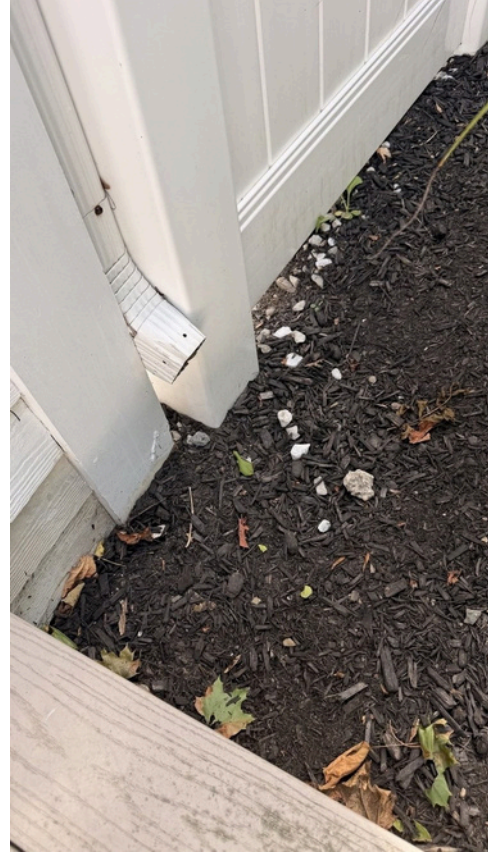
A hole/opening was observed at the far-left corner of the CMU foundation, and water is entering the basement at this area. Directly outside the corresponding corner, a roof downspout terminates immediately beside the foundation and discharges onto the stone at the base of the house.

The location of the interior leak closely coincides with the exterior downspout discharge. Concentrating roof runoff at this corner is a significant contributing condition because the water is being delivered directly to the soil and stone immediately beside the foundation instead of being carried away from the building. Repairing only the interior opening would leave the exterior water source in place.

*Downspout terminating directly at the foundation and discharging into the stone adjacent to the house.*

**Recommendation:** Repair the CMU opening and extend the downspout with solid drainage piping to an appropriate discharge location away from the foundation.

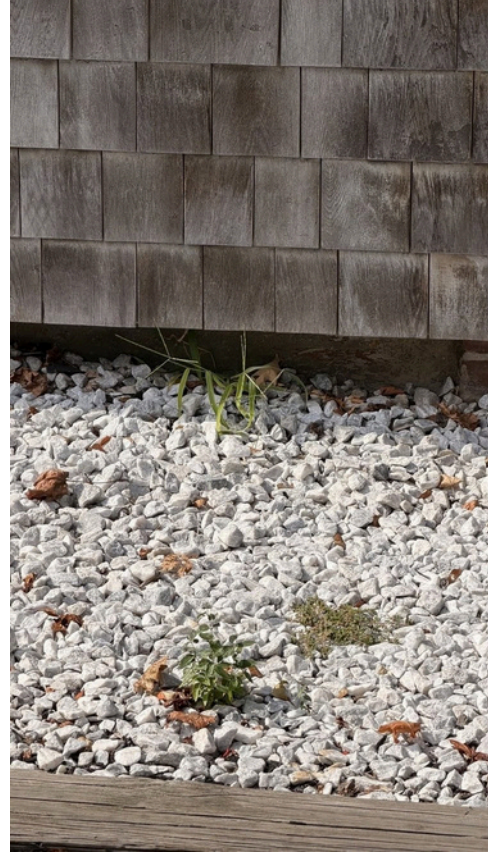
The home sits very close to exterior grade, with limited exposed foundation between the surrounding surface and the lower portions of the building. Decorative crushed stone is installed directly adjacent to portions of the foundation. The stone itself is not a drainage system and can allow water to move quickly toward the foundation unless a designed drainage system below it carries that water away.

Because there is little exposed foundation, water problems at this property are not limited to the basement wall. Roof runoff, splash-back, melting snow and saturated ground can also reach lower wood siding, wall sheathing, sill plates, rim joists and concealed framing at the foundation transition.

Repeated wetting can contribute to mold growth, wood decay and deterioration. If concealed structural wood remains wet long enough, its integrity can eventually be affected.

*Very limited foundation exposure above exterior grade with crushed stone directly adjacent to the building.*

**Recommendation:** Improve roof-water management first. Where accessible, inspect lower siding, sheathing, sill and rim-joist areas for prolonged moisture exposure or decay. Regrading opportunities are limited by the site, so controlled collection and discharge of roof water are especially important.

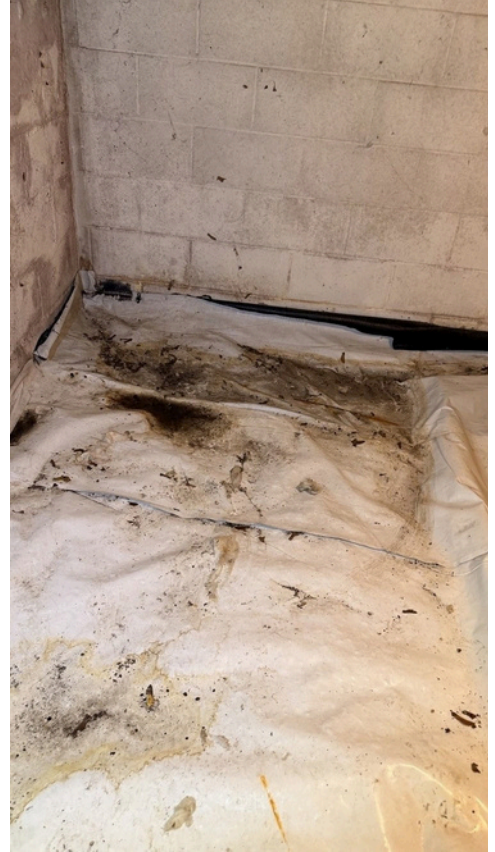
The basement floor currently consists of crushed stone covered by an exposed plastic vapor barrier. The membrane is heavily stained, wrinkled, loose in areas and difficult to clean. Water entering through the foundation is reaching the floor area, and visible contamination is present on top of the membrane.

Rodent activity was also observed during the inspection, including droppings on top of the floor membrane and around the electrical-panel area. An exposed plastic membrane does not provide a rodent-resistant floor. Rodents can travel beneath, around and over the loose membrane, and the many perimeter gaps and penetrations provide additional pathways.

The existing exposed membrane is therefore not recommended as the final long-term floor system for this basement.

*Existing exposed floor membrane showing staining, contamination and loose/wrinkled installation.*

**Recommendation:** Remove and dispose of the exposed membrane. Have rodent activity addressed and entry points identified/sealed. Rodent droppings should be cleaned using appropriate precautions or by a qualified pest/remediation contractor.

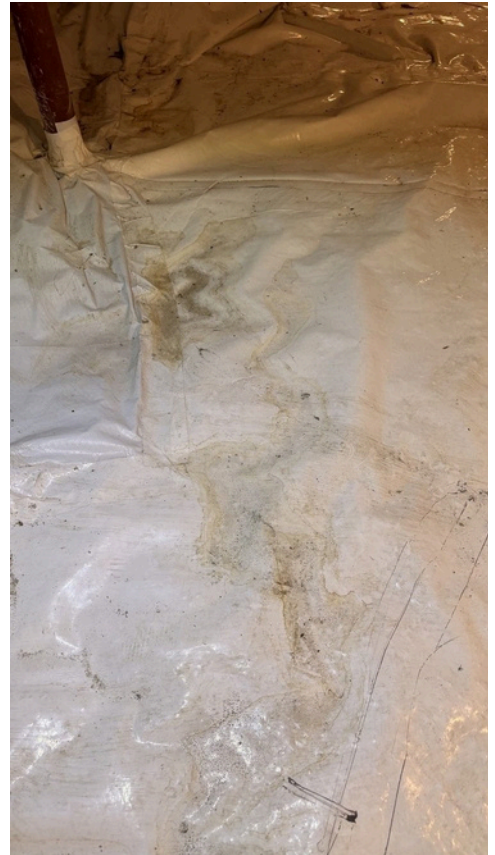
A new concrete floor is recommended in place of another exposed vapor-barrier system. After removal of the existing membrane, the crushed-stone base should be cleaned, regraded and compacted/prepared as necessary to create a stable and reasonably uniform sub-base.

A new vapor barrier should then be installed beneath the concrete slab, with seams and penetrations properly sealed. Placing the vapor barrier below the concrete protects the membrane, provides a durable and cleanable finished surface, improves control of ground moisture and soil-gas pathways, and removes the large loose-plastic environment currently available to rodents.

*Current exposed membrane over crushed stone. Recommended replacement is a sealed sub-slab membrane protected beneath a concrete floor.*

- ☐ Remove existing exposed floor vapor barrier.
- ☐ Clean, regrade and prepare the crushed-stone base.
- ☐ Adjust the sump basin/pump to the correct finished elevation for the new slab.
- ☐ Install a sealed sub-slab vapor barrier beneath the concrete.
- ☐ Properly seal around the sump, radon piping and other penetrations.
- ☐ Pour a new concrete basement floor to provide a solid, serviceable surface.

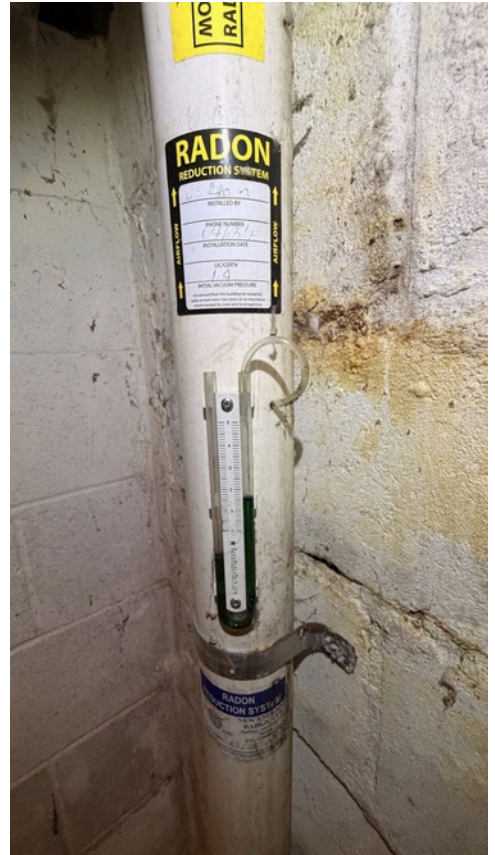
An active radon mitigation system is present. The U-tube manometer shows a pressure differential, indicating that the system is creating suction. The manometer is not a radon concentration meter and does not show the amount of radon in the basement.

The presence of a mitigation system does not guarantee that all radon is being captured or that current indoor radon levels are acceptable. This is particularly important in a basement with crushed stone beneath the floor, an incompletely sealed floor membrane, a concealed sump basin, foundation openings, wall-to-floor joints and multiple foundation construction types.

The client reported that the property was not radon tested after the mitigation system was installed. Therefore, there is no confirmed post-mitigation measurement demonstrating how effectively the system is controlling radon at this time. **Recommendation:** Perform a radon test to establish the current radon concentration. Retest after floor reconstruction, sump sealing or other work that changes the sub-slab air pathway. The new sub-slab vapor barrier and concrete slab should be coordinated with the existing radon system.

*Existing radon mitigation pipe and U-tube manometer. The gauge confirms suction, not the actual radon level.*

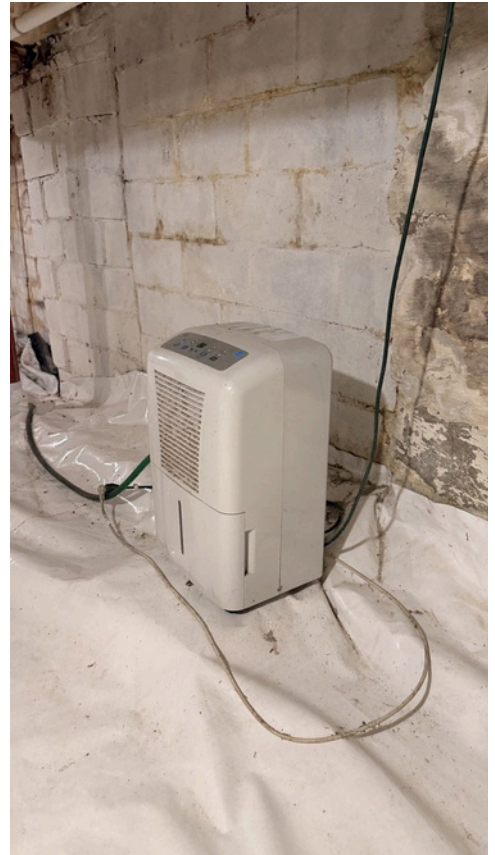
The basement has no windows, so there is essentially no natural window ventilation or natural drying. This makes mechanical moisture control especially important after bulk-water sources are corrected.

A portable dehumidifier is currently present. Dehumidification can reduce airborne humidity, but it cannot stop water from entering through the foundation. Water-management repairs should come first, followed by reliable mechanical dehumidification to keep basement relative humidity under control.

The home also uses a forced hot-air system. Basement air can communicate with upper living areas through duct leakage, framing cavities, stairways, penetrations and normal pressure differences within the home. Because visible staining and growth consistent with mold were observed, correcting moisture sources and cleaning/remediating affected materials is important to the overall indoor environment. No laboratory mold testing was performed as part of this inspection.

*Existing portable dehumidifier in the basement near moisture-affected CMU and stone foundation areas.*

**Recommendation:** After water intrusion is corrected, maintain mechanical dehumidification and target a stable basement relative humidity appropriate for the season and equipment. Evaluate and clean moisture-affected materials as needed.
